TECHNICAL NOTES

ASSORTED MANUFACTURERS

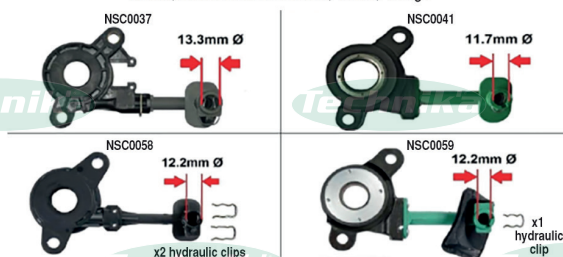
Multiple design slave cylinders installed by vehicle manufacturers

The diameter of the hydraulic connections are the main difference between them.

Nissan Almera II, Micra III, Note, Qashqai, Tida
Dacia Duster, Logan, Logan Express/Pick up/MCV, Sandero
RENAULT Clio II/III/Grandtour, Fluence, Kangoo, Rapid, Laguna II, Mégane II/III,
Modus, Scénic Grand Scénic II, Thalia, Twingo

When replacing cylinders, please ensure the diameters of the hydraulic connections on the old and new parts match. If the wrong hydraulic connection is installed, it will cause leaks and system failure.
